REC-ERC-84-22

EVALUATION AND ANALYSIS OF MOTOR STARTING PROBLEMS AT FOUNTAIN VALLEY PUMPING PLANT

March 1984

Engineering and Research Center

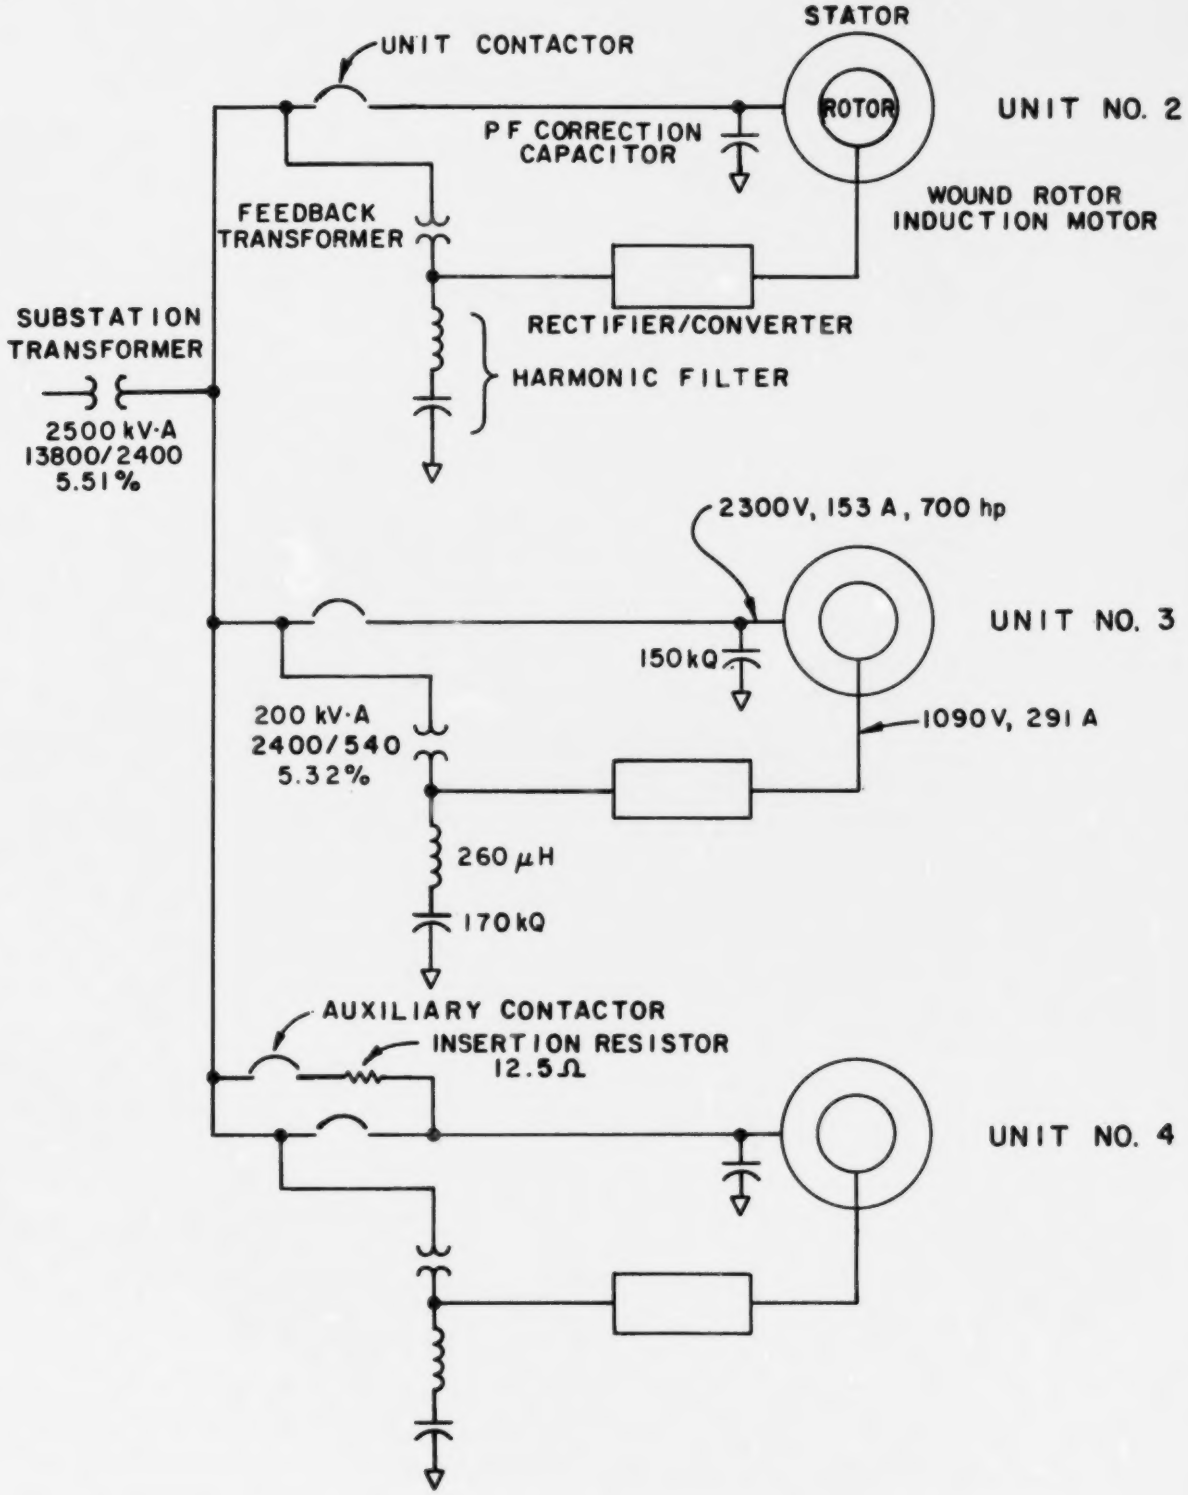
Figure H-12. – Insertion resistor configuration.

The capacitor modifications separately, and in conjunction with rewiring the feedback transformers to the line side of the unit contactors, were not successful in eliminating the startup problem. However, the insertion resistor scheme was most successful in eliminating the problem. There were 22 successful startups out of 22 attempts. Based on this success record, it was recommended that each of the Fountain Valley units be modified for insertion resistor starting.

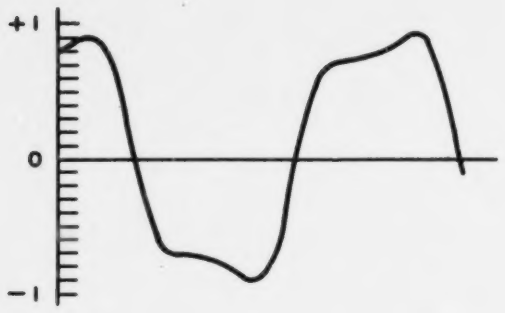
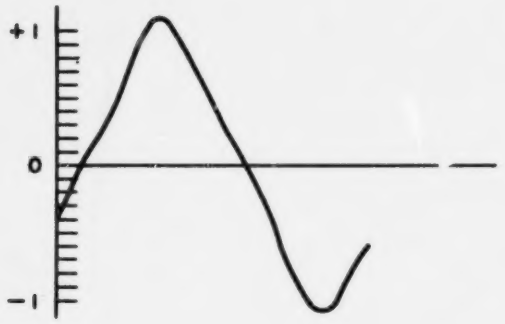
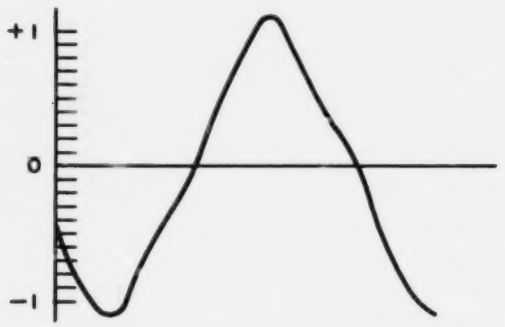
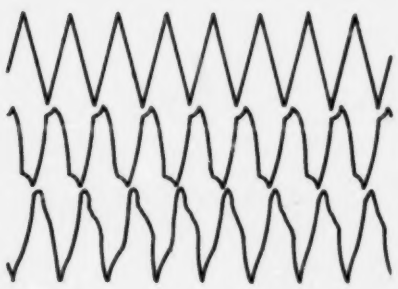
Figure H-13. – Worksheet for harmonic analysis.

The unit 2 filter current waveforms improved substantially between the period of the initial surge and steady state. The major change observed in these waveforms was the large decay of the harmonic content. The predominance of what appears to be a third harmonic like component in the initial transient current waveform is to be expected since the filter is tuned to the 3.3 harmonic.

The B-phase waveform is interesting in that it is practically a triangular shaped waveform and is therefore easy to analyze. Based on a Fourier analysis, the triangular waveform, when broken down into cosine components, has a fundamental component equal to 81 percent of the peak (180 A_{rms}) and 11 percent of the fundamental third harmonic (20 A_{rms}). The 5th and 7th harmonics are 4 and 2 percent of the fundamental, respectively; contributions from higher

In support of the previous analysis, the filter current waveforms were duplicated on paper from only the fundamental and 3.3 component. In the graphical construction, the 3.3 cosine component was assumed to be synchronized to the B-phase cosine fundamental. This assumption was necessary to obtain a B-phase triangular waveform. The three composite waveforms were generated by adding the fundamental to 11 percent of the 3.3 frequency component. This produced fairly accurate reproductions of the B- and C-phase waveforms but failed to produce the correct A-phase waveform. However, a nodal analysis of the circuit indicated that to preserve current balance, the A-phase waveform should be composed of the fundamental minus two times 11 percent of the 3.3 component. This resulted in a very good reproduction of the A-phase current waveform. The reproductions are shown at the top of figure H-13. The actual oscillograph current trace waveforms obtained during test 9B (fig. H-8) are shown at the bottom of figure H-13.

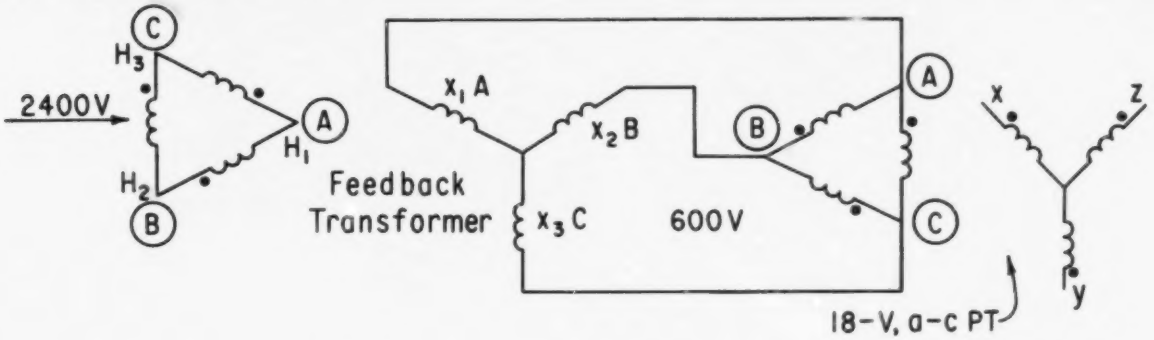
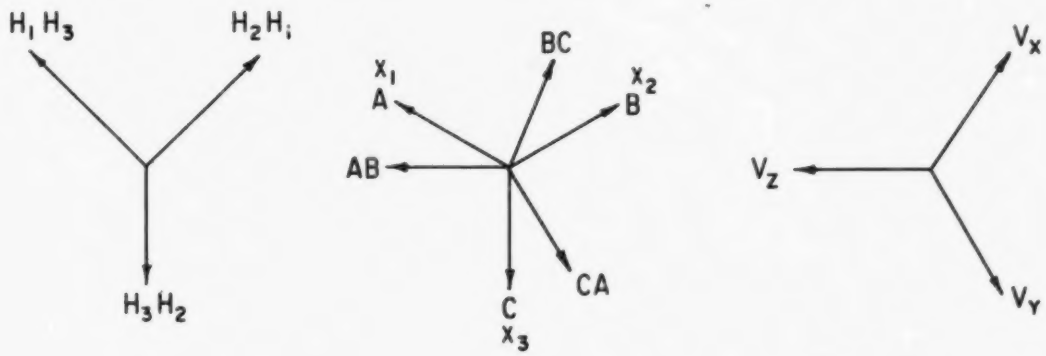
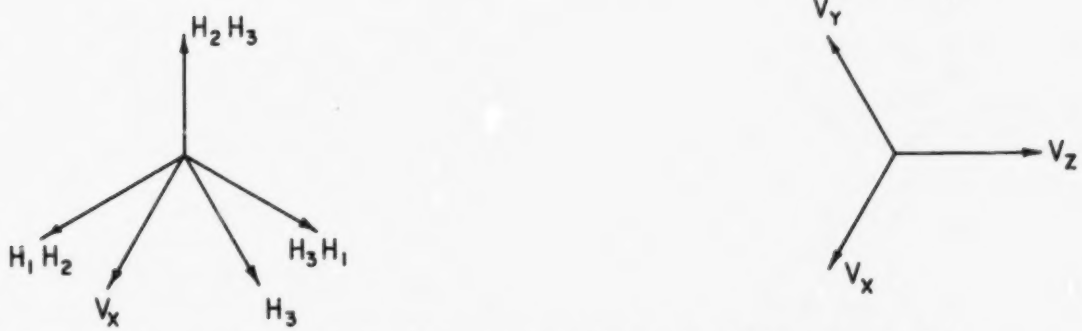
Transformer Connections

Note: As can be seen from this vector check, H_3 leads X_3 by 30°; and

This matches the oscillograph record:
- V_X leads H_1 H_2 by 30°
- V_X leads H_2 H_3 by 150°
